Category 1 – Basic Transportation

Category 9 – Shipboard Vibration

Appendix A – Vibration Summary Report

Appendix B – Random Vibration Summary

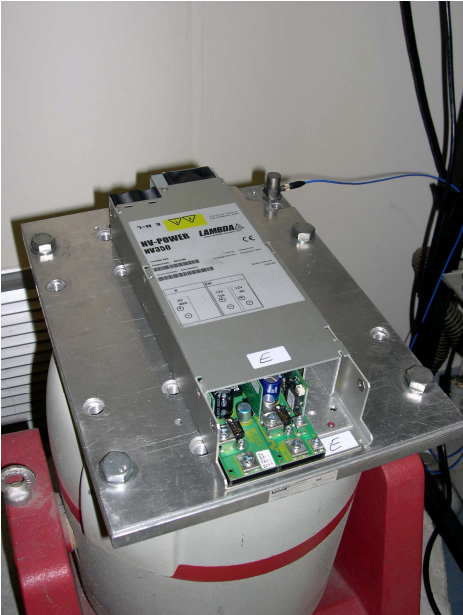
Plane 1 :

The unit was subjected to the following test with the unit mounted in each of the three planes as indicated below .

The unit was mounted onto a 3mm flat or right angle aluminium plate using the M4 customer fixings. The plate was in turn mounted to the vibration table. Mechanical inspection and Electrical testing was performed before the test. The following tests were performed :

Resonant frequencies : Plane 1 – 85Hz, 115Hz
 Plane 2 – 103Hz, 138Hz
 Plane 3 – 101Hz, 153Hz

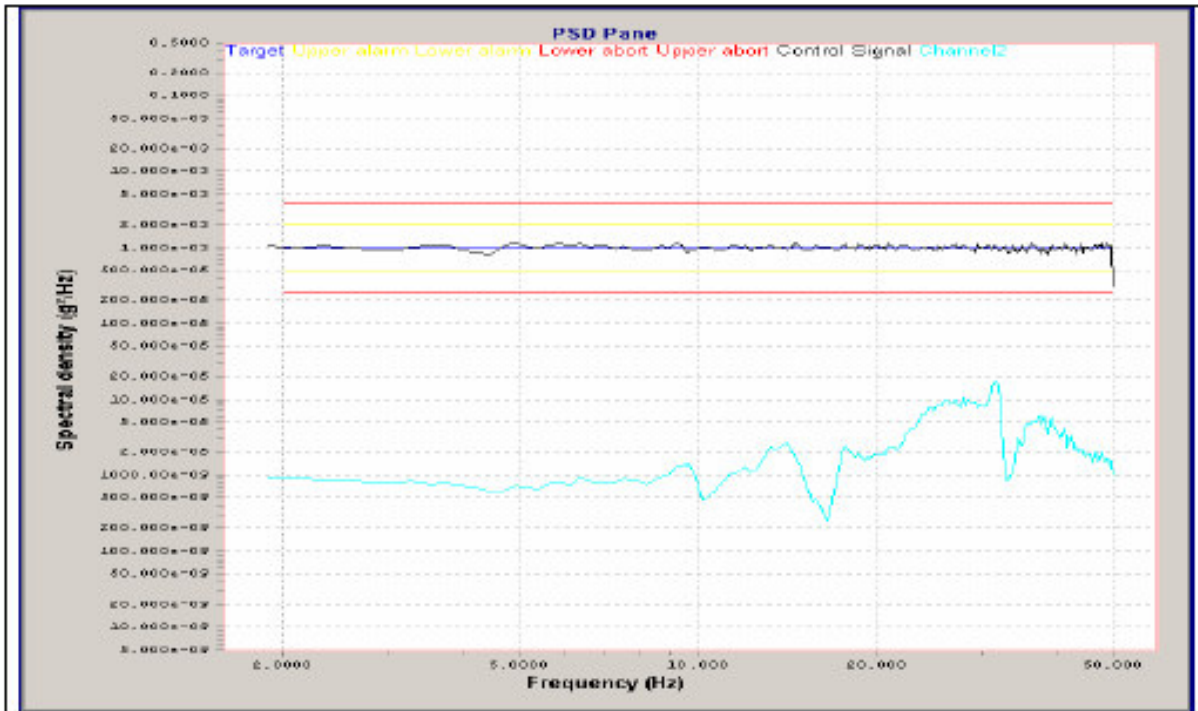
Direction Z Black line control, Blue line cross axis
